12
FC
TECHNICAL REPORT M-186
August 1976

FAILURE ANALYSIS OF OZARK, ARKANSAS,
POWER PLANT SOCKET-HEAD CAP SCREWS

by
E. P. Cox

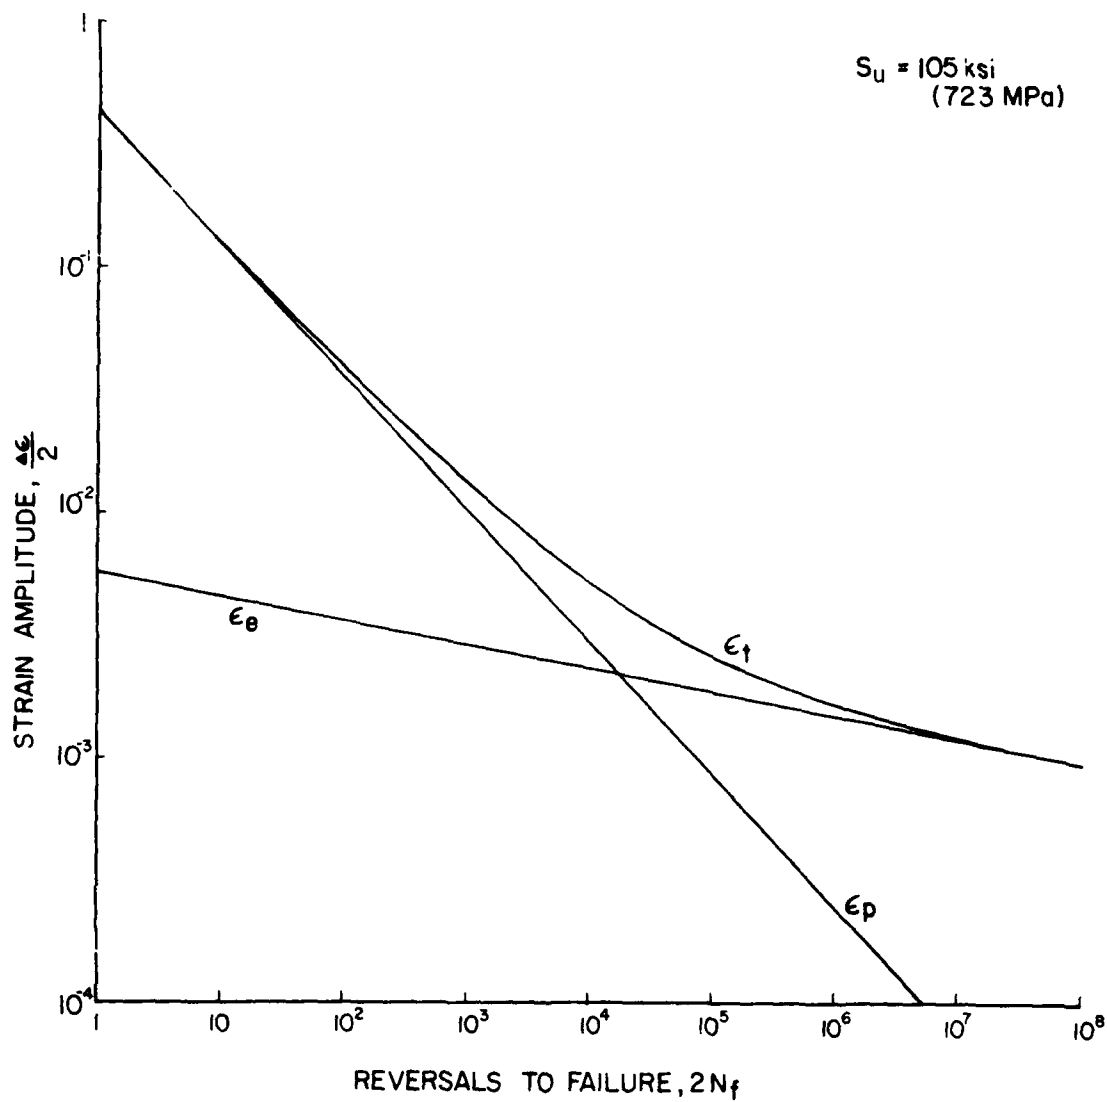
Strain vs. cyclic life data for AISI 4340 steel were found for the hardness of interest in the *Ford Motor Company Databook*.⁷ The strain vs. life curves were modified to account for a mean stress of 25 ksi (172 MPa); these curves are presented in Figure 16 for a hardness of 23 R_c (243 BHN) and in Figure 17 for a hardness of 38 R_c (350 BHN). Using these data, a Neuber analysis of the notch equation (Eq 7) can be used to compile a stress vs. cyclic life curve for a notched member (Figure 18).

Figure 16. Strain amplitude vs. fatigue crack initiation life for AISI 4340 steel heat-treated to hardness of 23 R_C and having a 25-ksi (172 MPa) mean stress. (The above data are for smooth specimens.)

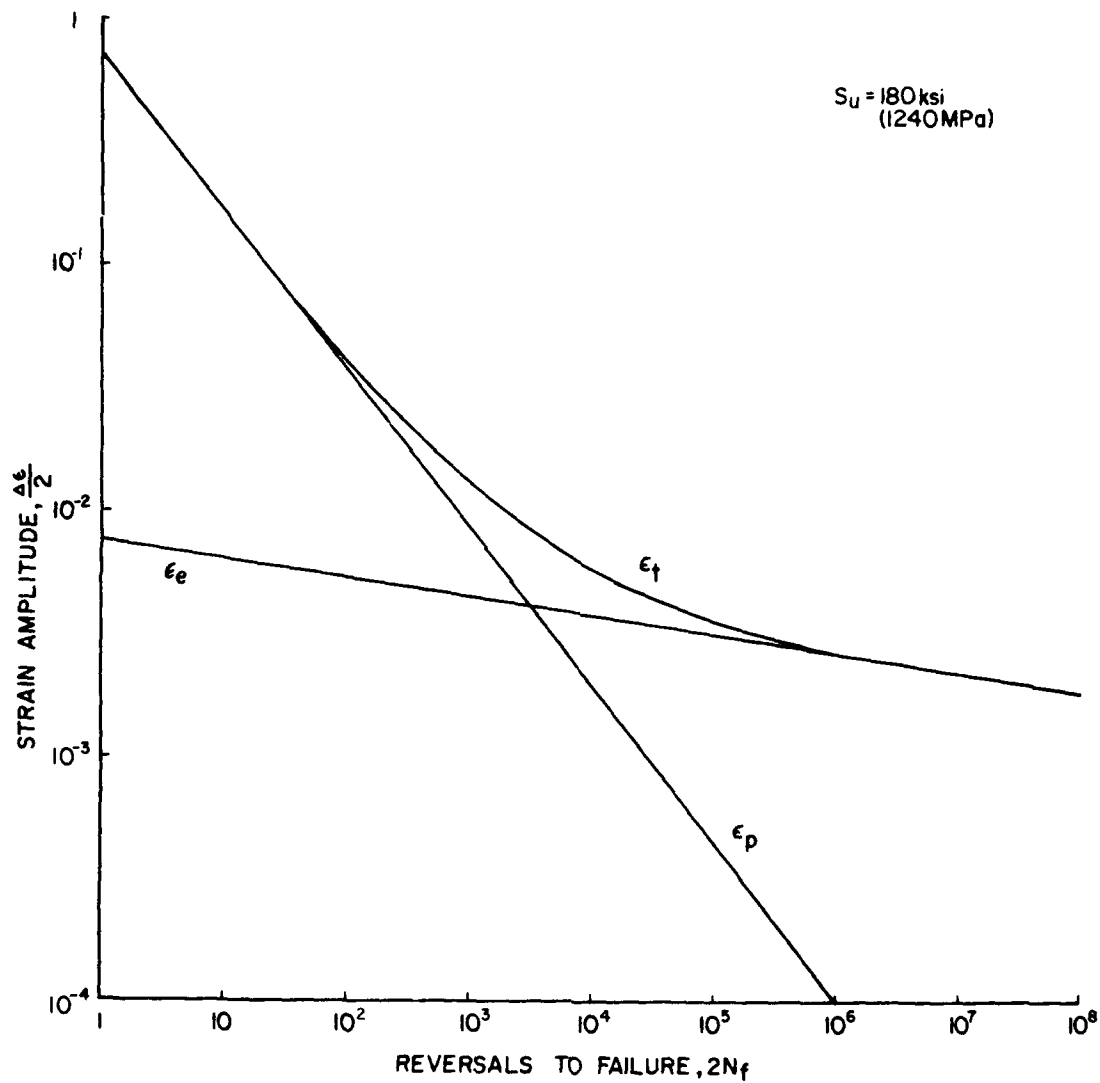
Figure 17. Strain amplitude vs. fatigue crack initiation life for AISI 4340 steel heat-treated to hardness of 38 R_C and having a 25 ksi (172 MPa) mean stress. (The above data are for smooth specimens.)

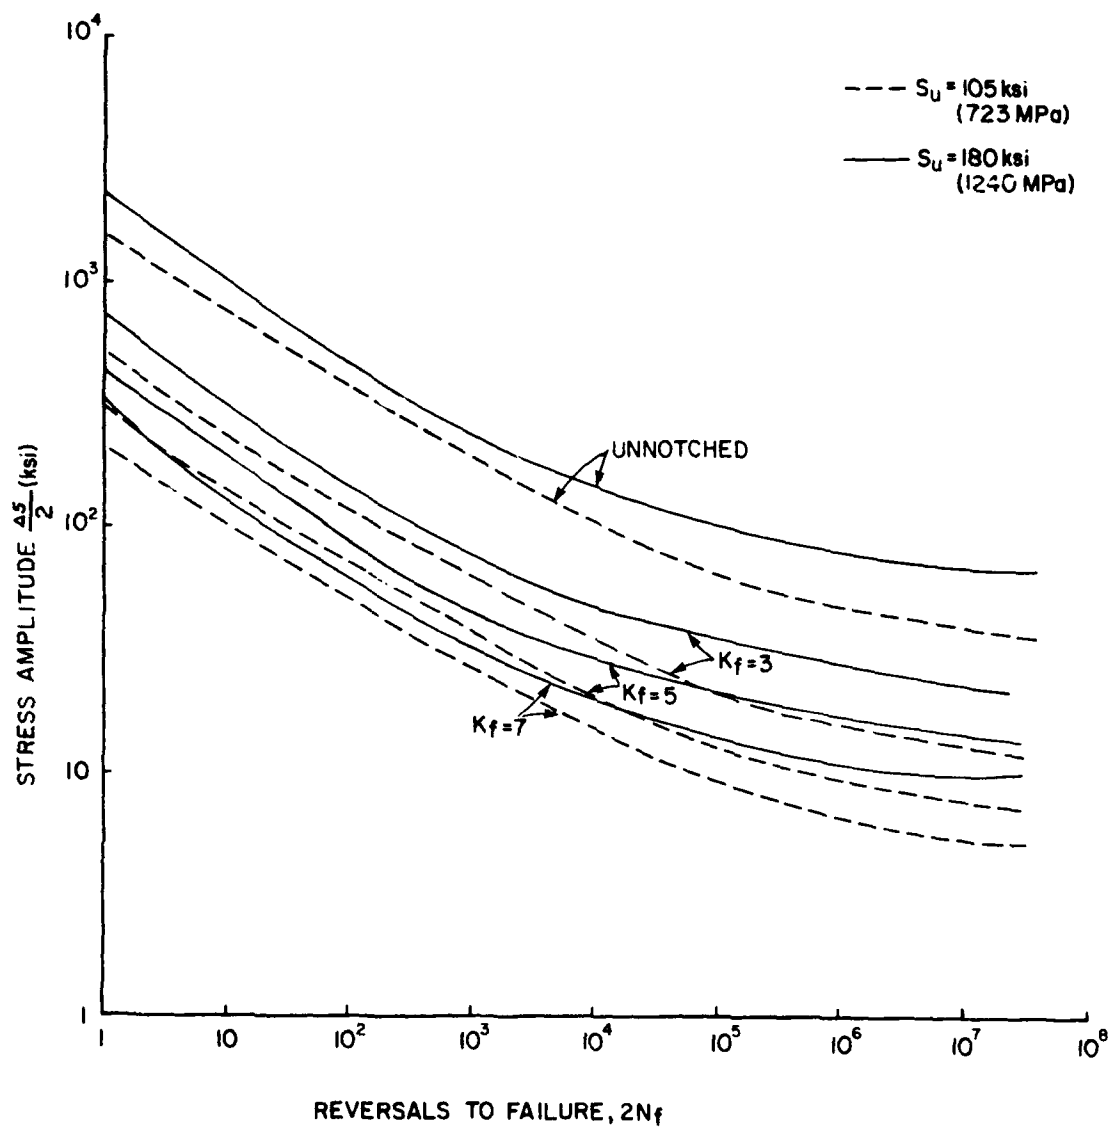
Figure 18. Notched specimen fatigue crack initiation life for various stress amplitudes. Unnotched specimen behavior is included for comparison with specimens containing fatigue strength reduction factors (K_f) of 3, 5, and 7. (The data shown are for a cyclic mean stress of 25 ksi [172 MPa].)
